SUPERFUND THIRD FIVE-YEAR REVIEW REPORT**for****A.L. Taylor (Valley of Drums)****Operable Unit 01****Brooks, Bullitt County, Kentucky****PREPARED BY:****US Army Corps of Engineers, Louisville District****for****US Environmental Protection Agency, Region 4
Atlanta, Georgia****February 2003**

SUPERFUND THIRD FIVE-YEAR REVIEW REPORT

A. L. Taylor (Valley of Drums)

Brooks, Bullitt County, Kentucky

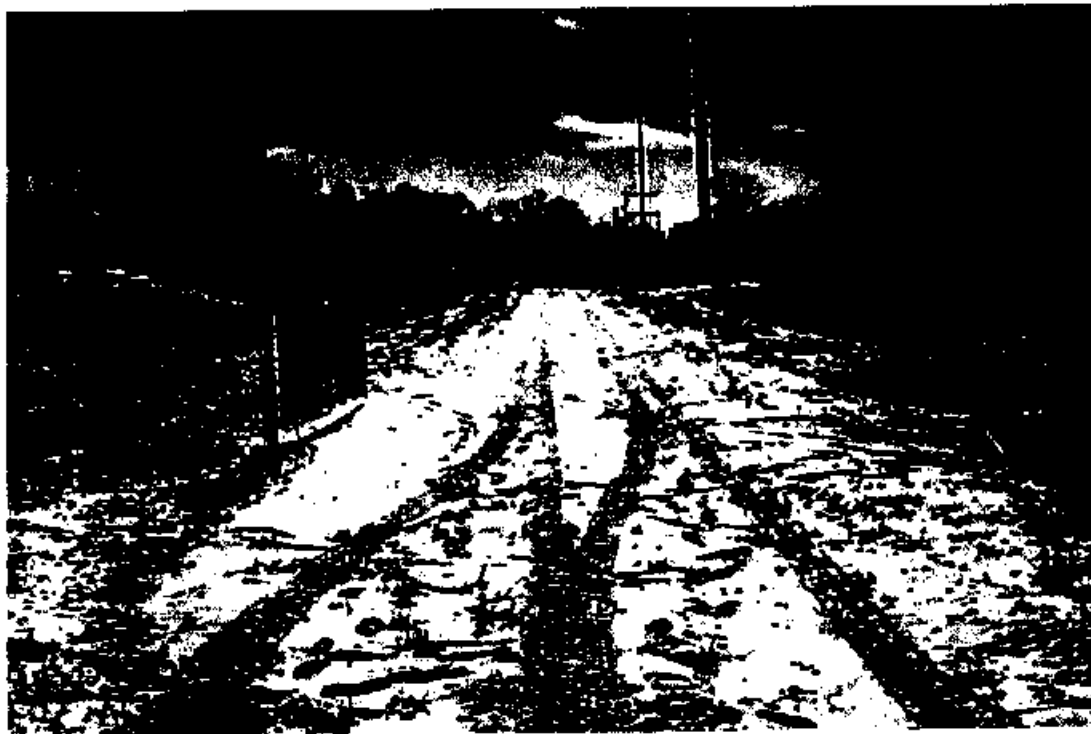
surrounding the landfill is in excellent condition. The front and rear gates are securely locked with padlocks. In addition to KDNREP, Louisville Gas & Electric (LGE) has access through both front and rear gates since their power lines traverse the Site. Proceeding along the access road through the Site, USACE observed that the road is in excellent condition and the rear gate is locked and in good condition (Photo #20).

Photo #20 Southerly view of rear gate and Access Road traversing the cap. Louisville Gas & Electric power poles on west edge of Access Road.
